7.8 SHINGLEMILL SUBBASIN 3 STREAM HABITAT CLASSIFICATION

7.8.1 General Characteristics

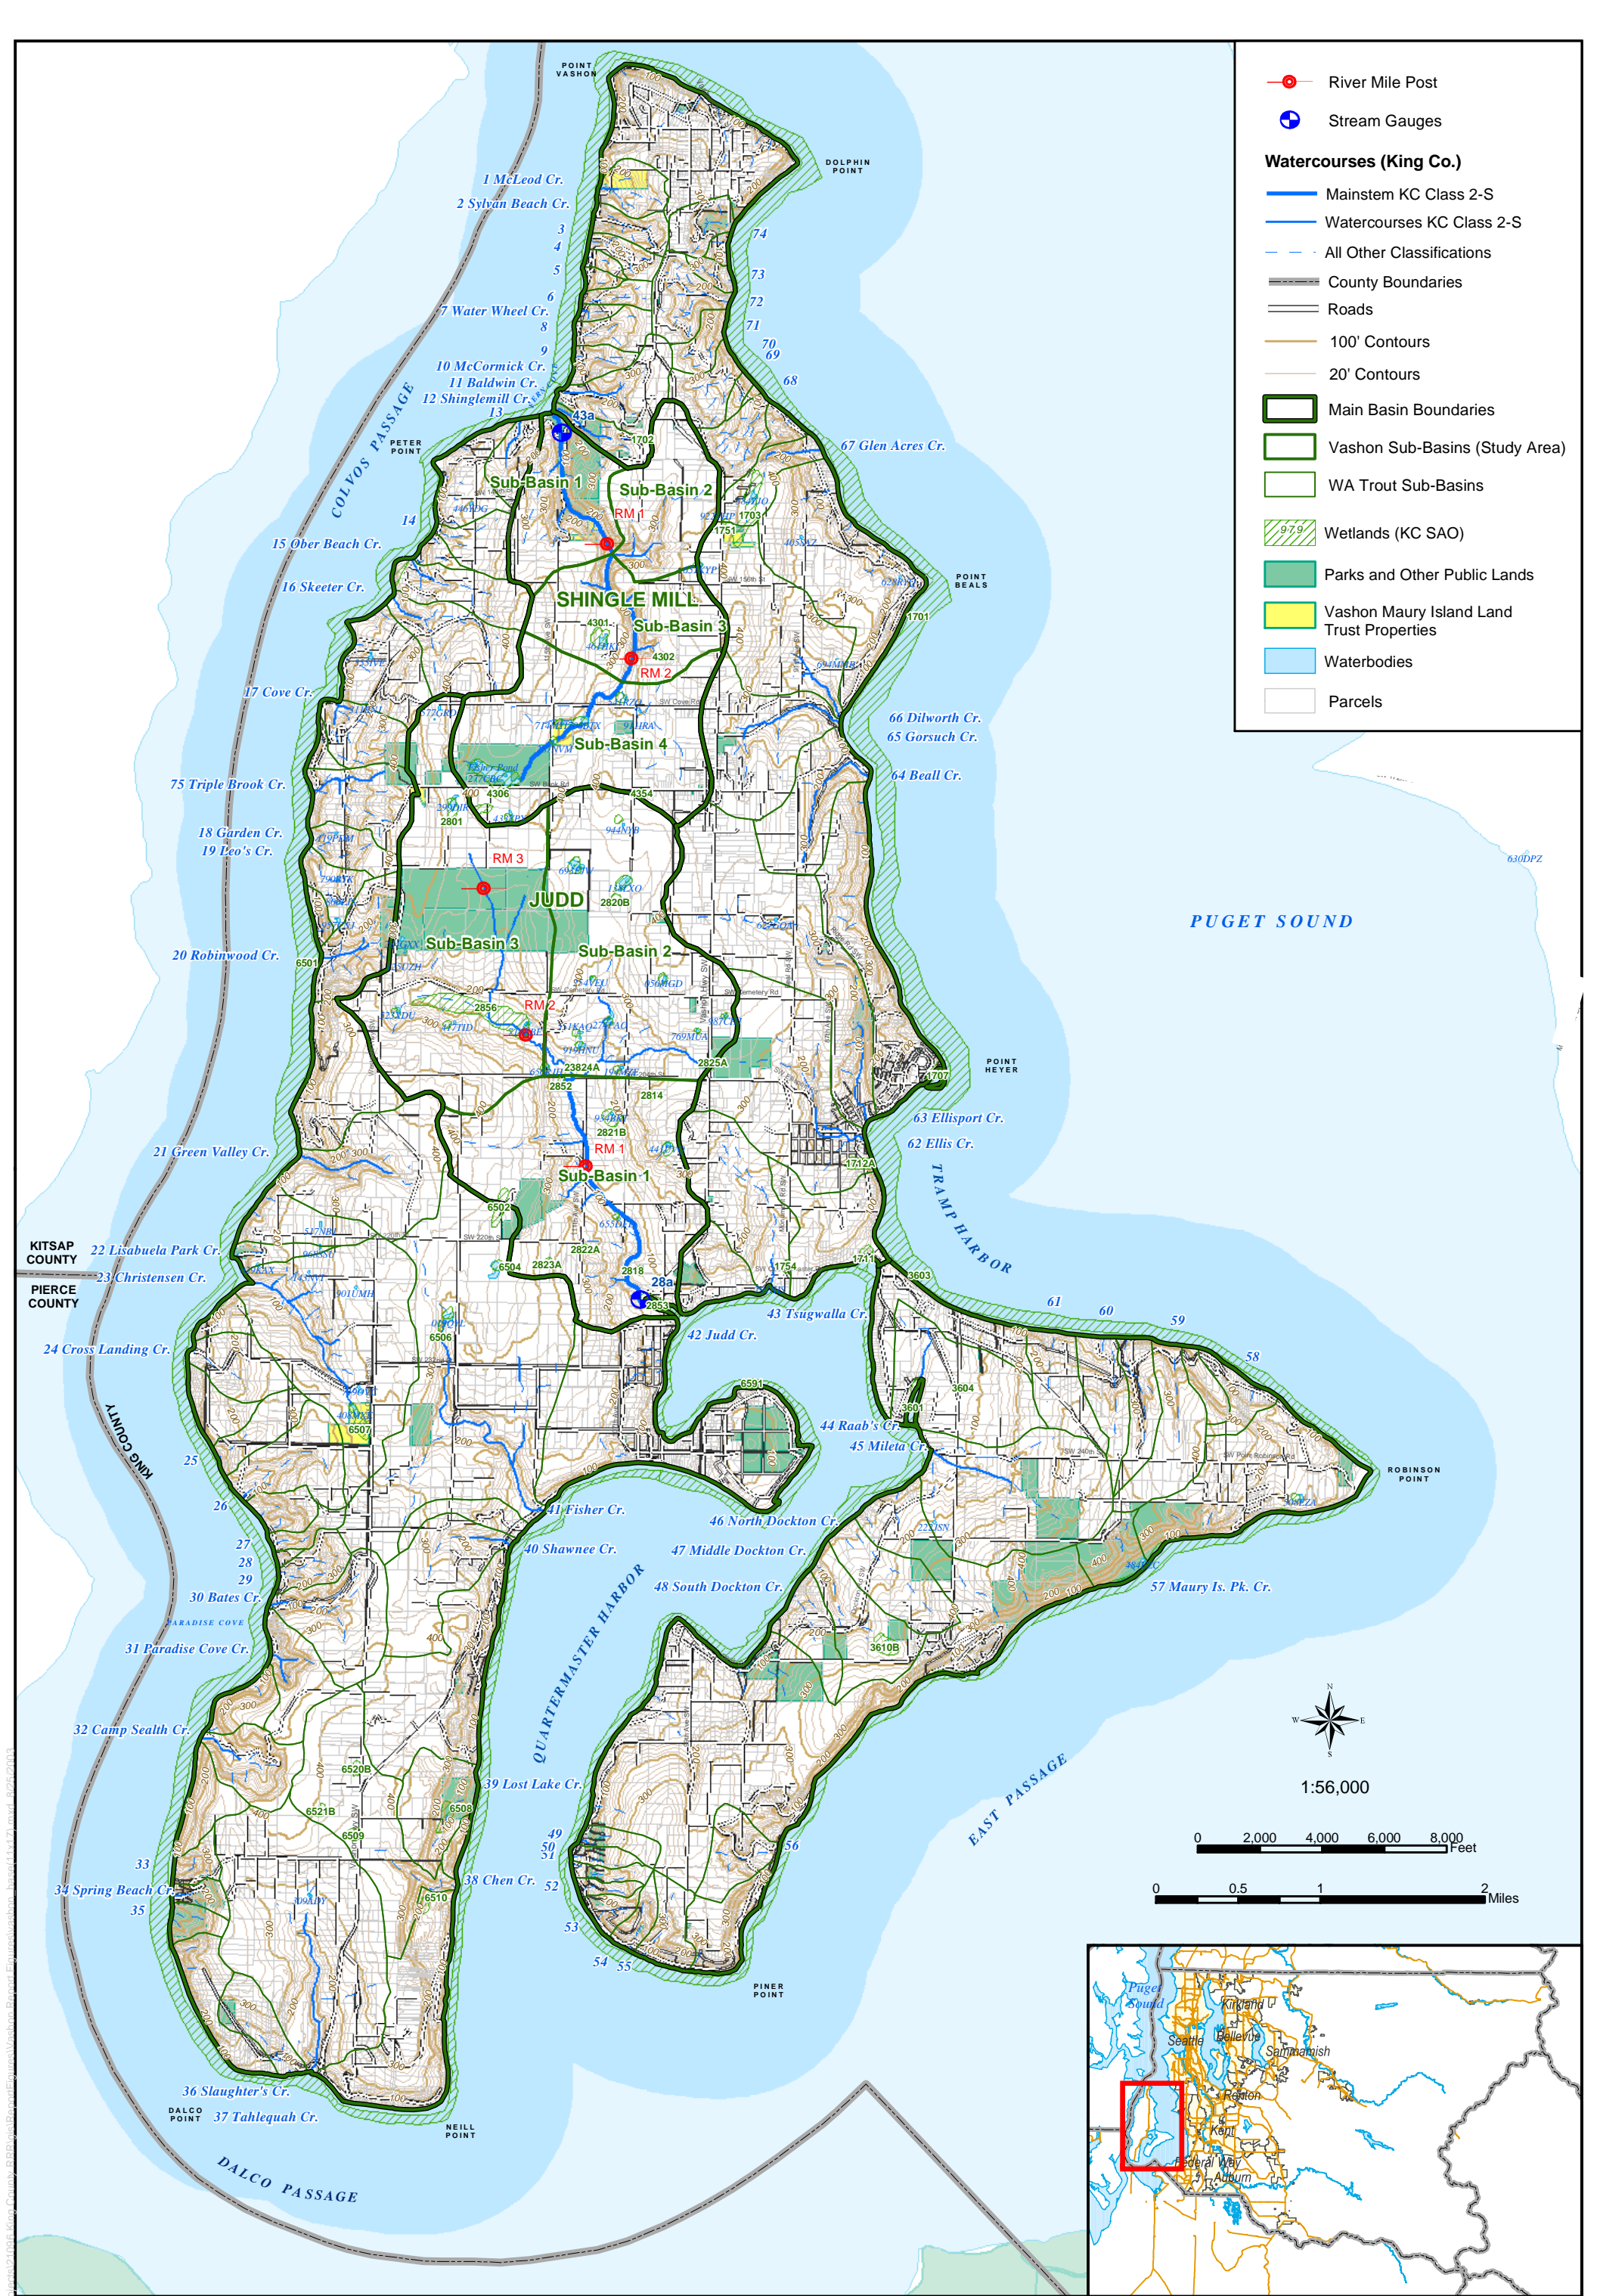
Shinglemill Subbasin 3 consists of a forested landscape with a mix of rural residential and agricultural development, and contains the main stem of Shinglemill Creek and six small tributaries (Figure 7-1). The total length of Class 2 stream is 5,000 feet. The Vashon Municipal Airport is a notable feature in the subbasin. Shinglemill Creek is a moderate-gradient contained channel type and the tributaries are all high-gradient contained channel types (Figure 7-3).

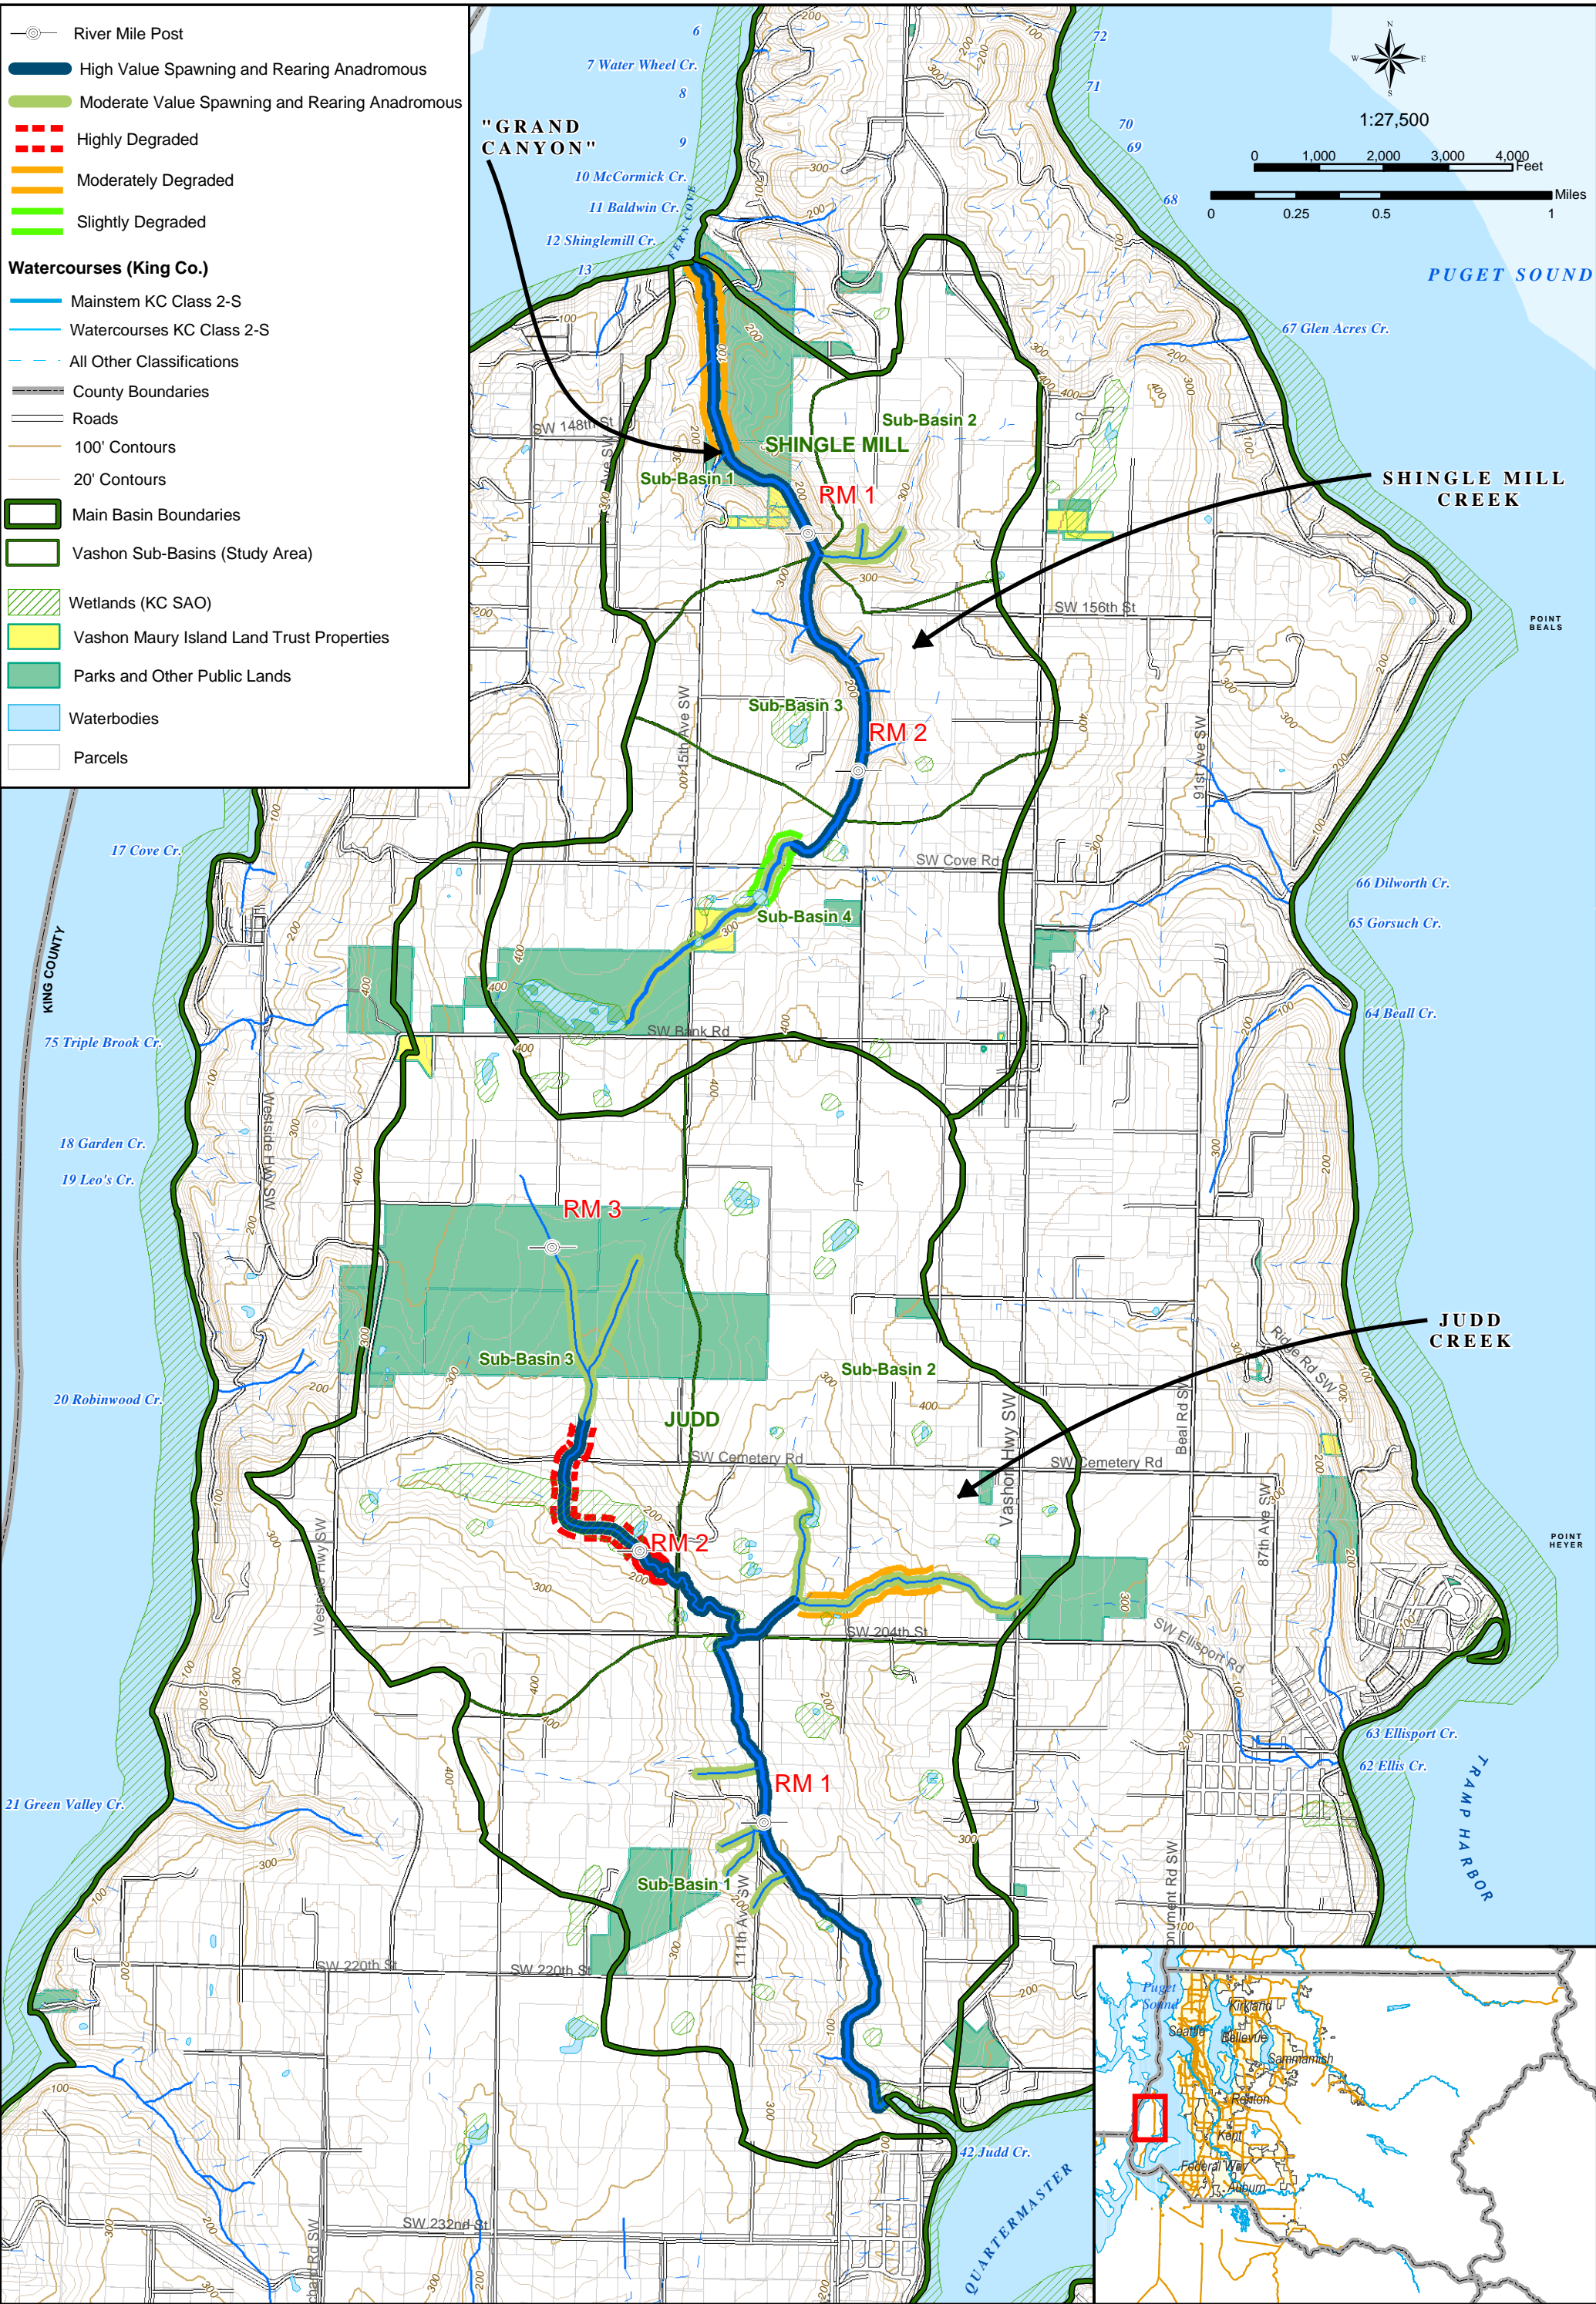
Suitable and valuable salmonid habitat exists in Judd Creek, but there are reaches that have been degraded (Figure 7-4). The basin is primarily a forested landscape with areas of rural residential and agricultural
